## Bearing Wear Example #1 – Inner Race Fault

Alan Friedman – DLI Engineering

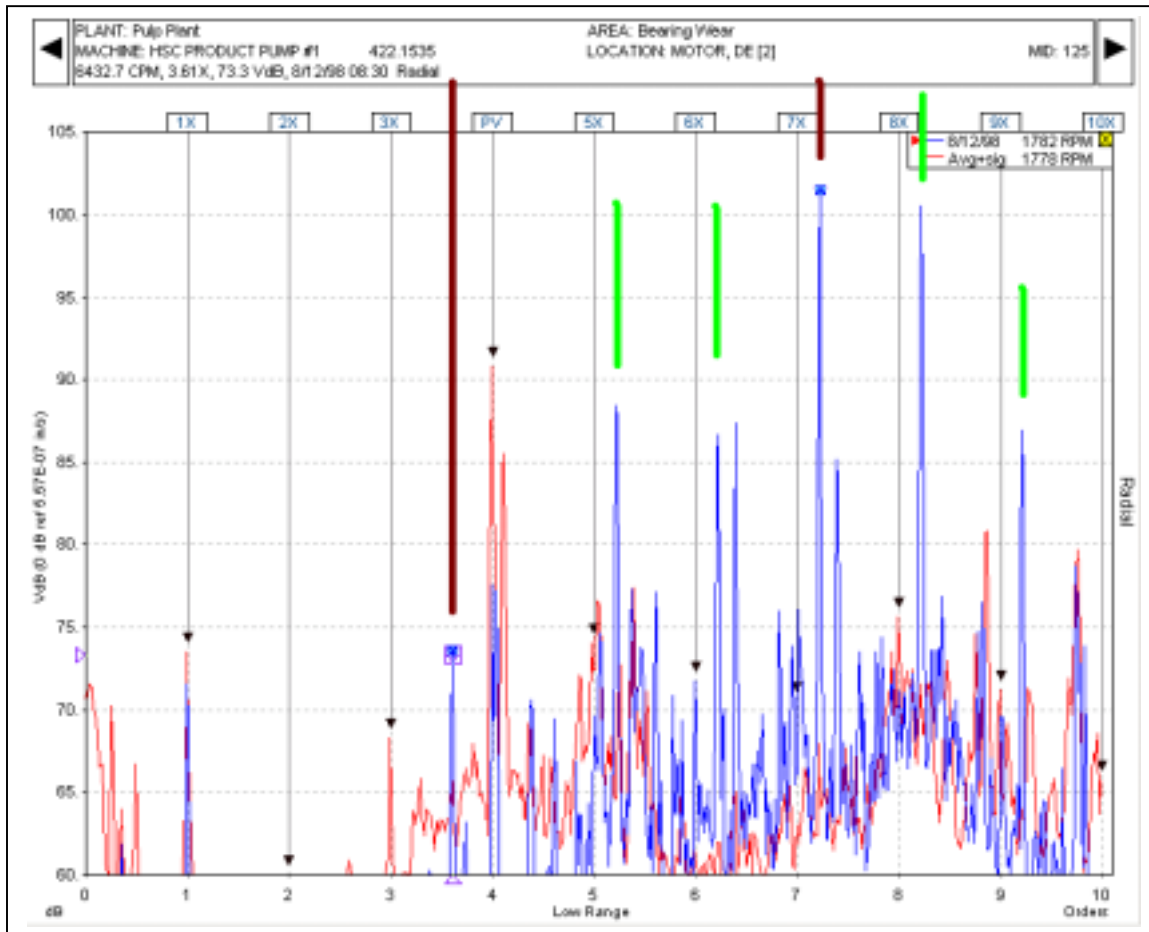
(Figure 1, Vibration Data – Motor End)

The red colored spectrum is a prior measurement from the same machine, which is used as a reference; the blue colored spectrum is the latest data. Without knowing anything about vibration analysis it is obvious that there are peaks in the blue spectrum that were not in the red spectrum. This is our first clue that something has changed.

The horizontal axis of this graph is in “orders” where “1” indicates the running speed of the machine. The first rule about bearing tones is that they rarely appear at frequencies that are exact multiples of the shaft rate. As we can see, many of the large peaks in the blue spectrum do not line up with shaft multiples.

The peak on the left marked with the maroon line falls at a frequency of 3.61x the shaft rate. This is a fundamental bearing tone, and we can see a harmonic of this tone, also marked in maroon, at 7.22x.

If we measure the distance on the graph between 0 and 1 on the horizontal axis with a scrap of paper, we will have a measurement of the shaft frequency of the machine. Moving the marked scrap of paper over to the peak at 7.22x, we can see that the peaks marked with green lines are separated from the peak at 7.22x by the run speed of the machine (they are at frequencies of 5.22x, 6.22x, 8.22x, 9.22x). These peaks are called “1x sidebands” and are caused by a fault in the bearings’ inner race traveling in and out of the load zone with every shaft revolution. If one considers that the weight of the horizontal shaft is at the bottom of the machine, it will be clear that as a fault on the inner race travels down, it hits the balls harder. When the fault on the inner race is at the top of the machine, it hits the balls more softly. This repetitive change in the impact forces is called amplitude modulation, and this is what causes the 1x sidebands. If we take the same scrap of paper and place it by the peak at 3.61x, we will see that this peak also has 1x sidebands, although they are not marked on the graph.

The presence of 1x sidebands is common to bearing wear (when the fault is on the inner race) and therefore the existence of these sidebands confirms that these tones are in fact bearing related. If this vibration were coming from another machine next to the one we are examining for instance, it would not create this pattern of 1x sidebands, thus we can rule out external vibration.

The presence of new peaks in the spectrum at the motor end, that were not exact multiples of the shaft rate, was the first indication that a bearing problem likely existed. The presence of 1x sidebands around these bearing tones confirmed that this vibration was in fact bearing related, as external vibration would not cause this effect and because this pattern is common to inner race faults. Because the same peaks were present in both the motor and pump ends of the machine, demodulated data was utilized to confirm that the bearing problem was on the motor end. This is because the high frequency information used by the demodulation technique does not travel far and probably could not cross a flexible coupling. The presence of the same peak at 3.61x in the demodulated data from the motor end therefore confirmed that the problem was at the motor end.

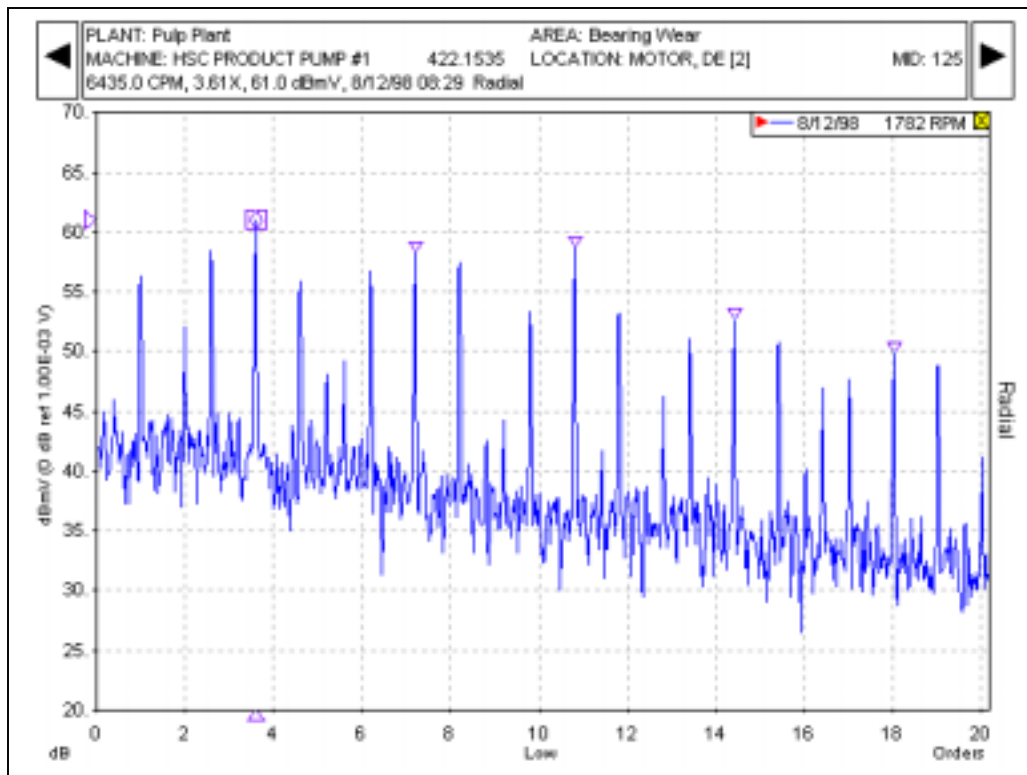
(Figure 2, Demodulated Data - Motor End)

Although we currently have more than enough evidence to confirm that this is in fact a bearing problem, a high frequency enveloping measurement (often called demodulated data) provides additional confirmation. As we shall soon see, this measurement also confirms that the bearing problem is on the motor end of the machine, not the pump end. The spectrum in figure 2 above is the demodulated spectrum from the motor end of the machine. Here we can see the same 3.61x peak (and harmonics) that we see in the spectrum in figure 1.

Because demodulated data results from a high frequency measurement, it is more sensitive to location. This is because high frequency vibration cannot travel as far and probably will not travel through a flexible coupling.

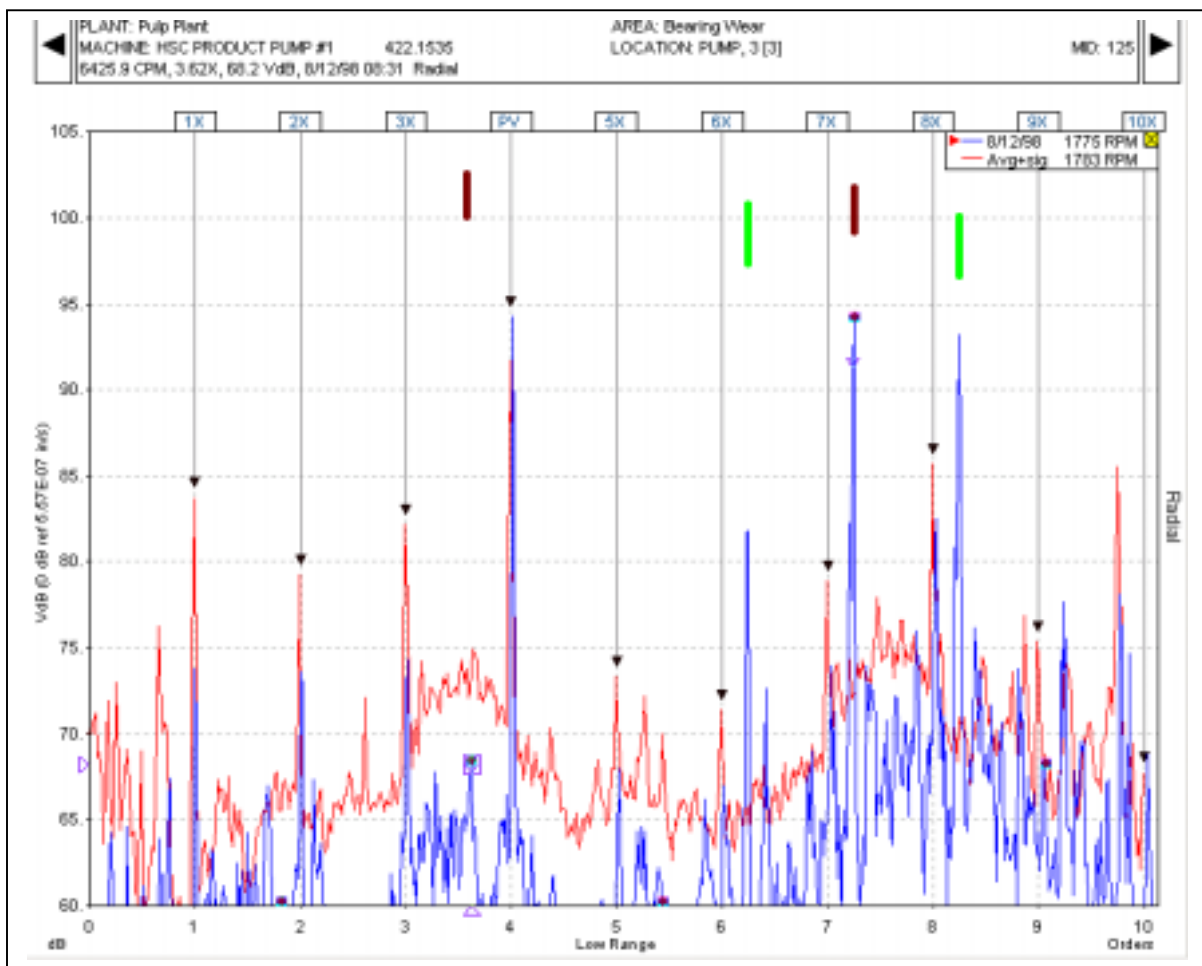
(Figure 3, Vibration Data - Pump End)

In figure 3 above, we can see that the same peaks marked in maroon at 3.61x and 7.22x that we saw on the motor end of the machine, as well as the 1x sidebands marked in green. If we had not already looked at the demodulated data, it would be difficult to determine at this point whether it is in fact a pump bearing or motor bearing that has a fault, since the vibration is apparently able to travel from one part of the machine to the other.

If demodulated data were not available, one could check calculated bearing frequencies to see if these tones coincide with expected failure frequencies (assuming the pump and motor have different bearings in them), or, one could make an assumption that the vibration levels should be higher the closer one is to the faulty bearing. Unfortunately, the latter assumption is not always correct.

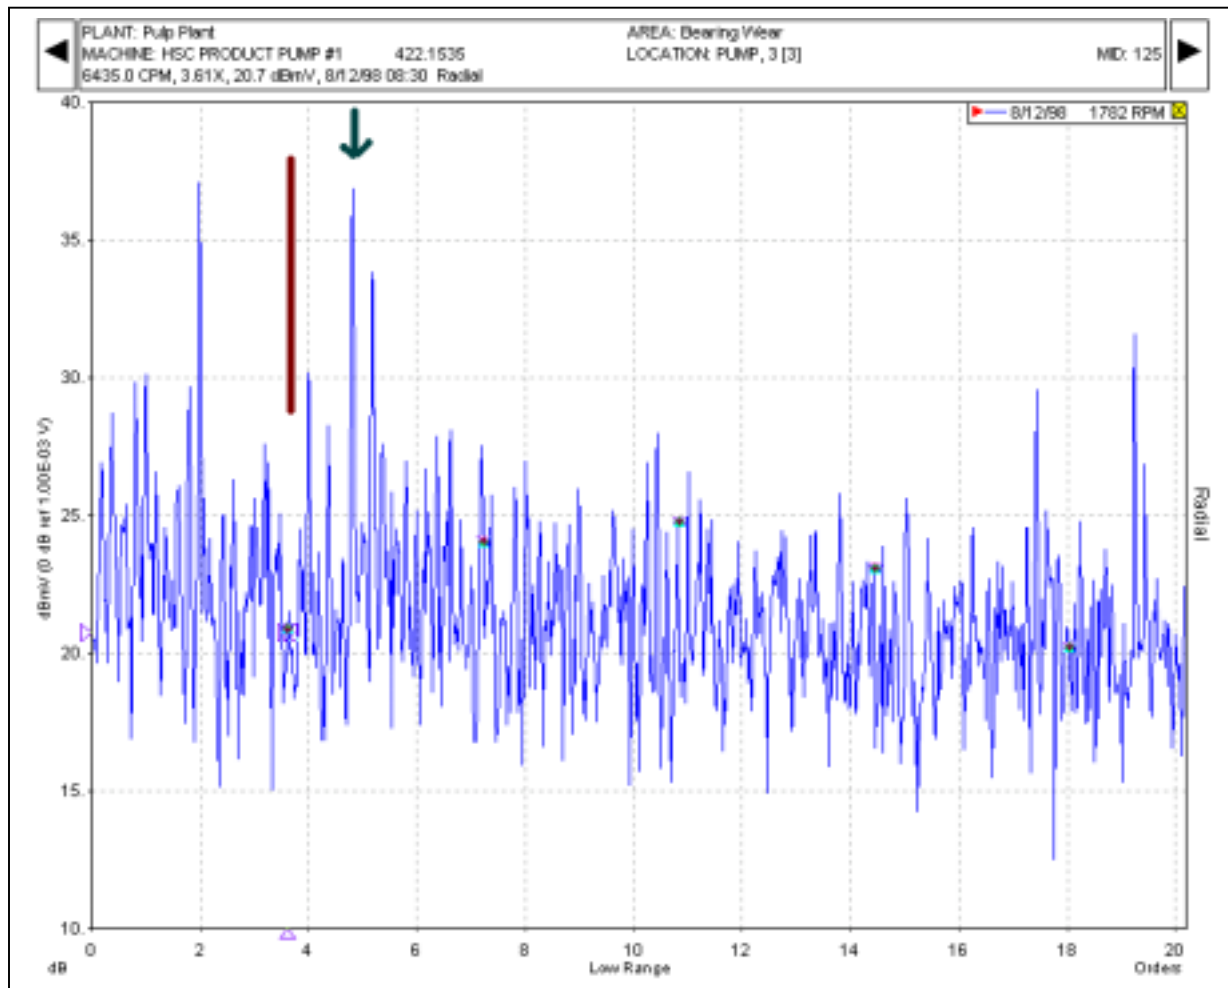
(Figure 4, Demodulated Data – Pump End)

In figure 4 (above), we have the demodulated data from the pump end of the machine. We can see here that there is no peak at 3.61x (marked in maroon) as there clearly was on the motor end demodulated data (figure 2). This is again due to the fact that the high frequency demodulated signal could not cross the coupling. Therefore, we now have confirmation that the fault is at the motor end.

There is a peak at 5.4x however, marked with a green arrow in figure 4. This is a distinct bearing tone on the pump end that is being detected in the demodulated spectrum. If we go back to the regular vibration data from the pump (figure 3), the peak at 5.4x cannot be found. This is because the demodulation technique is much more sensitive to bearing faults than the normal spectrum and therefore we can see these bearing tones in the demodulated spectrum before they have enough energy to appear in the regular spectrum. This does not mean the bearing must be replaced however, it simply means a small fault is in its initial stages of development.

The demodulated data from the pump end did not contain this peak at 3.61x, but it did contain a bearing tone at 5.4x that did not appear in the spectral data from the pump end. This served as an indication that the pump bearings also had an incipient fault, although not severe enough to take action against. This is due to the fact that demodulation is quite sensitive to small faults. All of this information was easily determined without knowing the make or model of the bearing in question.
