Reducing Motor Bearing Failures – Modified Lubrication Procedures Improve Reliability at TVA

Jerry Honeycutt,
Tennessee Valley Authority

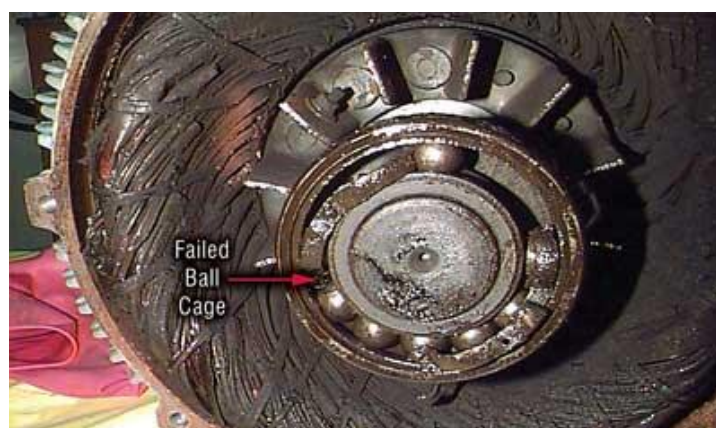
An example of a bearing failure due to bearing shields being pushed into the raceway as a consequence of overgreasing is shown in Figure 1.

This was a control rod drive (CRD) fan motor at Watts Bar Nuclear Plant. The bearing experienced a ball cage failure due to the bearing shield (Figure 2) being pushed down on the ball cage due to overpressurization of the grease cavity.

Install a pressure-sensitive (20 psi differential) grease-fill fitting that will not allow the cavity to be pressurized beyond 20 psi. This should minimize excessive pressure buildup on the bearing shield while the motor is being regreased.

Install a grease-relief valve-fitting to take the place of the grease drain plug. The grease-relief valve will open between 1 and 5 psi and will minimize risk of over-pressurization of the grease cavity from re-lubrication and thermal expansion of the grease (while running the motor).

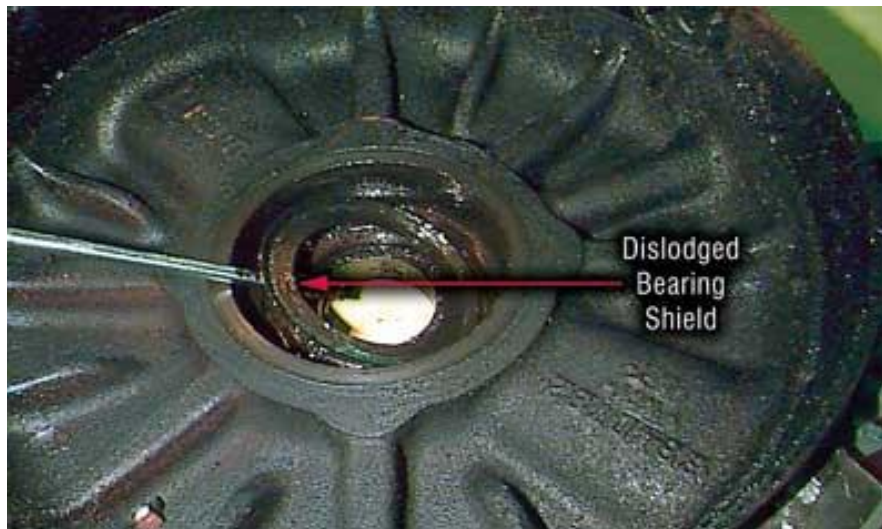
Figure 2.

End bell with bearing shield that has become dislodged from the bearing.
