Troubleshooting Paper Machine Problems Through Thermal Imaging

Robin J. Thon

Albany International Corp.

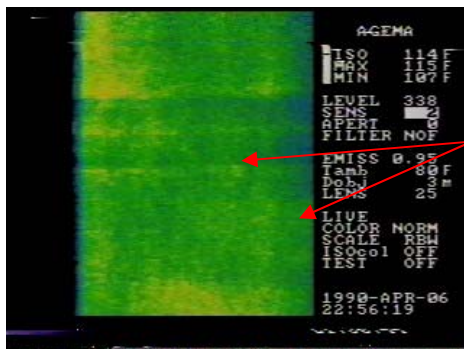
Image #1

A mill was getting complaints from a printing customer where a wet mark on the paper was causing problems in processing some of the paper. The source of the problem [see Image # 1] was identified using an IR camera in the coater drying section. The thermal image shows a mark caused by the seam of a dryer fabric. The mark is between the two red arrows across the image from left to right. Since there are more than one dryer fabric in the coater drying section, the exact length of the contributing dryer fabric was then calculated using a stopwatch and knowing the actual coater speed. The calculated fabric length came to 136.6'. Each of the dryer fabrics was then measured using a measuring wheel. The closest fabric length match was the 2nd bottom dryer fabric at 136.9'. When this fabric was replaced with a pin seam fabric, the problem disappeared.

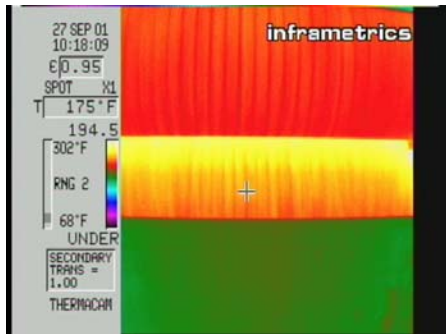
Image #2

Press section fabrics use high-pressure showers to keep them clean. Sometimes the shower flow-pattern is transferred to the paper web as illustrated in Image # 2. This condition can cause problems in the dryer section, such as rusting of return rolls which in turn leads to premature wear of the dryer fabric. In this analysis, the shower nozzles turned out to be worn and were putting more water into the press fabric than could be taken out, thus transferring wet streaks to the paper.

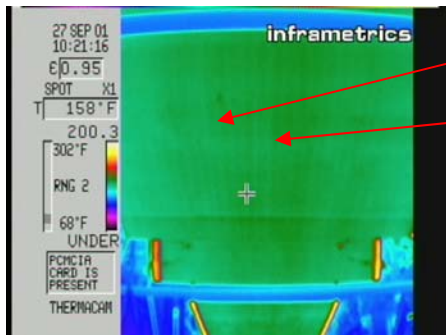
Image #3

Image # 3 shows the shower pattern from the Press section fabric transfer by the paper to the second bottom dryer section fabric, which is downstream in the paper manufacturing process. The two red arrows point out some of the shower patterns. Paper containing moisture streaks can adversely influence quality and performance of the paper in a subsequent converting and printing processes.

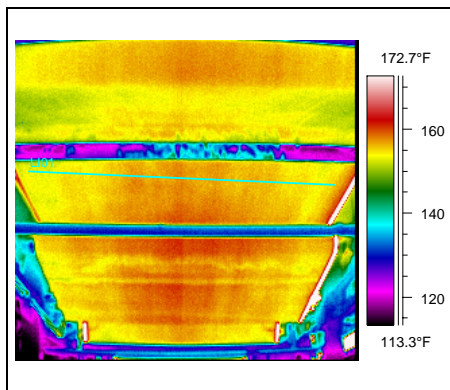
Image #4

After replacing the high-pressure shower nozzles, the shower nozzle pattern can no longer be seen [see Image # 4] in the dryer fabric.

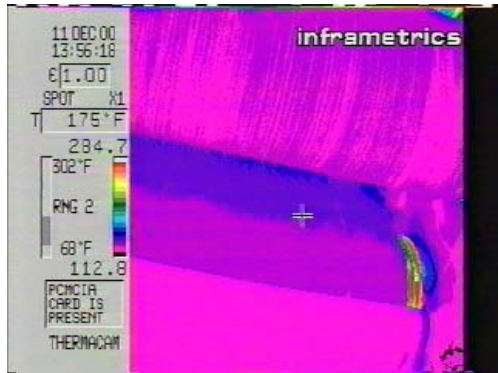
Image #5

The next two images show a Unirun dryer section fabric with before and after shots from the basement looking up to the first dryer section. Image # 5 shows a good Cross Machine Direction (CMD) profile.

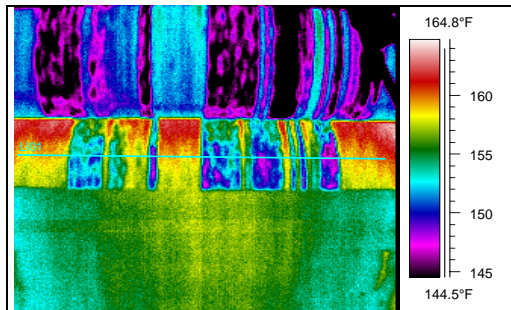
Image #6

Image # 6 of the same position shows a very poor CMD profile. In this case, a profiling steam box was used earlier in the process and this had to be eliminated as a wet streak contributor. A steambox can show a very erratic temperature profile. This image was taken with the steambox off to minimize the known variables that may contribute. The problem was then identified to originate at the continuous dryer-cleaning shower.

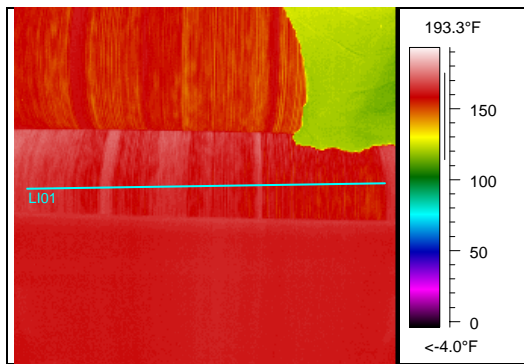
Image #7

After some maintenance on the cleaning shower pump the CMD profile shows much improvement.

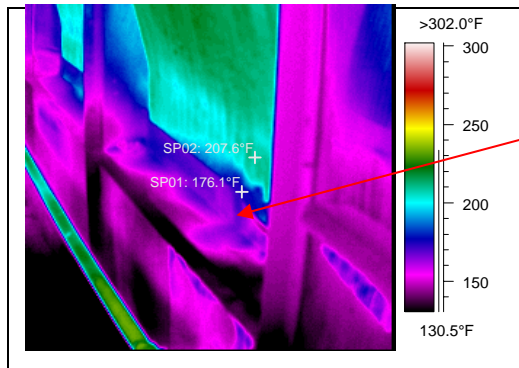
Image #8

Paper machine surveys are a routine part of our service to customers. These are intended to document good performance and to investigate known problems. Using the IR camera, we are able to “see” things, which are not visible to the eye. In Image # 8, we noticed several steam leaks on steam coils for the dryer section pocket ventilation system. Through our pre-survey meeting with this customer, we had learned that the paper machine was experiencing several unexplained paper breaks per month. The steam coils that were leaking were turned off. The remaining coils in each air supply bank provided enough warm air until the leaks could be repaired. The breaks per day were reduced and the mill gained about \$200,000 in increased production.
