# Inspection Report

<b>Image Date/Time</b>	Wednesday, September 10, 2002, 7:00PM
<b>Report Date/Time</b>	Wednesday, September 17, 2002
<b>User</b>	Paul Sjogren
<b>Location</b>	ABC Manufacturing Company
<b>Target</b>	Roof

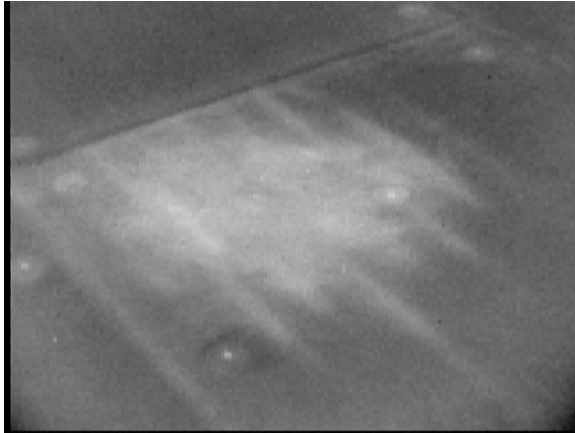
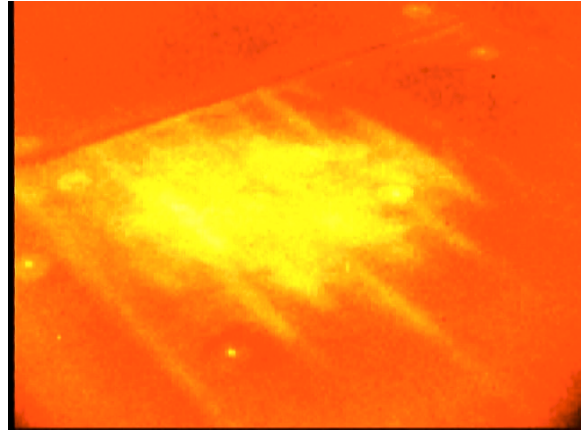
Temperature difference indicates potential water soaked insulation. The thermal image shows the extent of the moisture migration and the area needing repair. Failure to eliminate the moisture and its source may result in roof deck deterioration and repair at a much greater expense.

We recommend taking a core sample as further evidence and appropriate repair of the damaged area.
